# **Joint Final Report**

## **Little Last Chance Creek at Guidici Ranch Restoration Project**

**Prepared by  
Plumas Corporation  
January 2009**

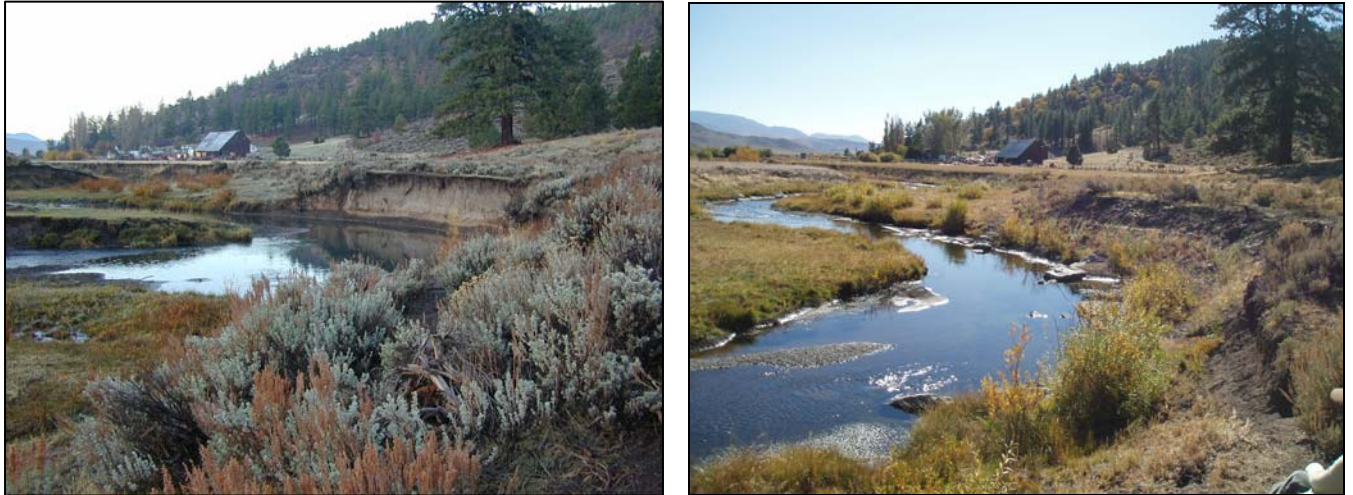
Figures 5 & 6. Pre- (left) and post-project (right) view of three treated banks in the pasture area.

Banks were treated by laying them back, and installing boulder vanes and a floodplain bench with rooted vegetation. Other revegetation work included seeding with commercial native grass and sedge seed, covering slopes with straw, and planting seedlings from the Feather River College greenhouse (see project description for list of species).

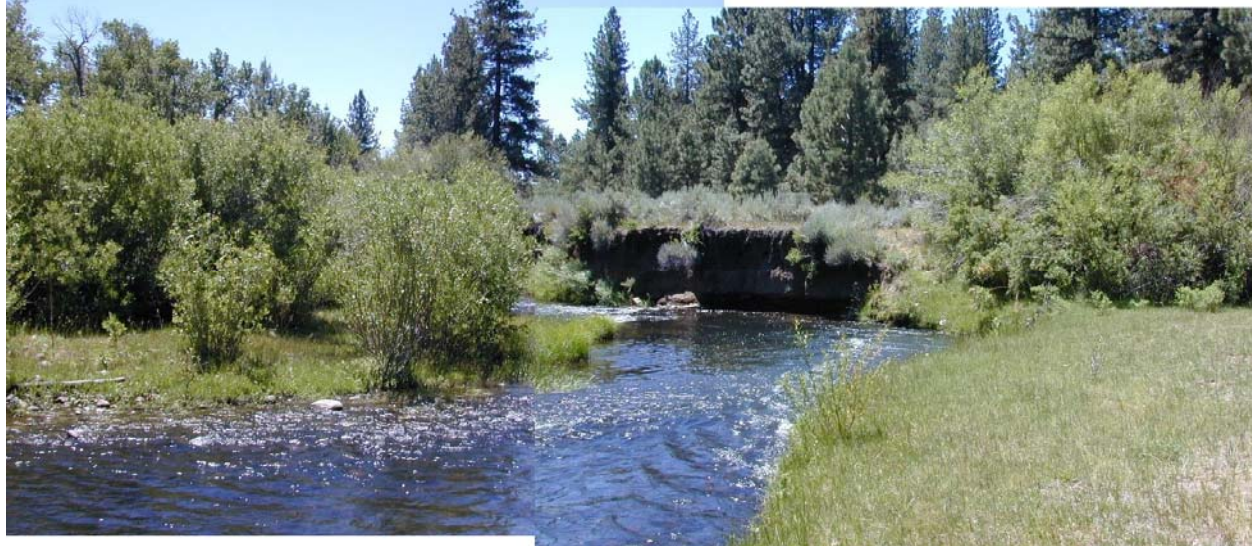
Figure 7. Treatment Area A in September 2005.

Figures 7 and 8 show another typical raw vertical bank that was treated. Here, as in most cases, rooted vegetation on the treated bank came from the opposite point bar. One of the objectives of the treatment was to equalize the vegetative resistance on both banks.

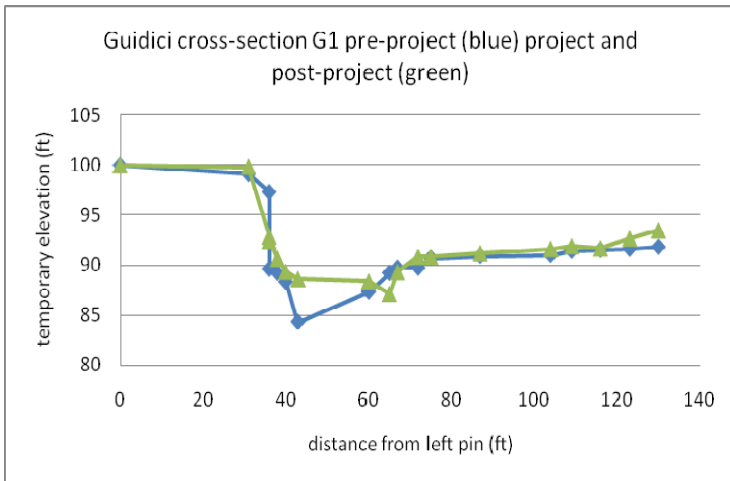
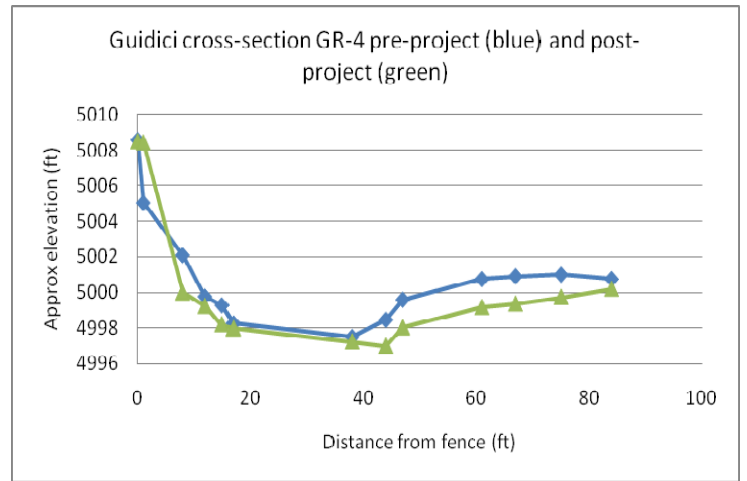
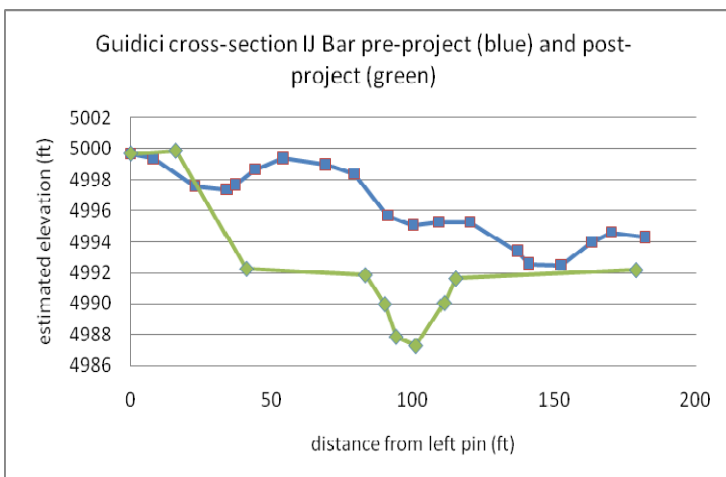
Figures 9-11. Pre- and post project cross-sections.

These three cross-sections show pre- and post-project bank lines. Cross-section G1 shows a floodplain bench replacing a deep pool at an actively eroding bank. GR4 shows a laid back bank and lowered floodplain opposite of the treated bank. IJ Bar shows a newly constructed avulsed channel through a relict terrace.

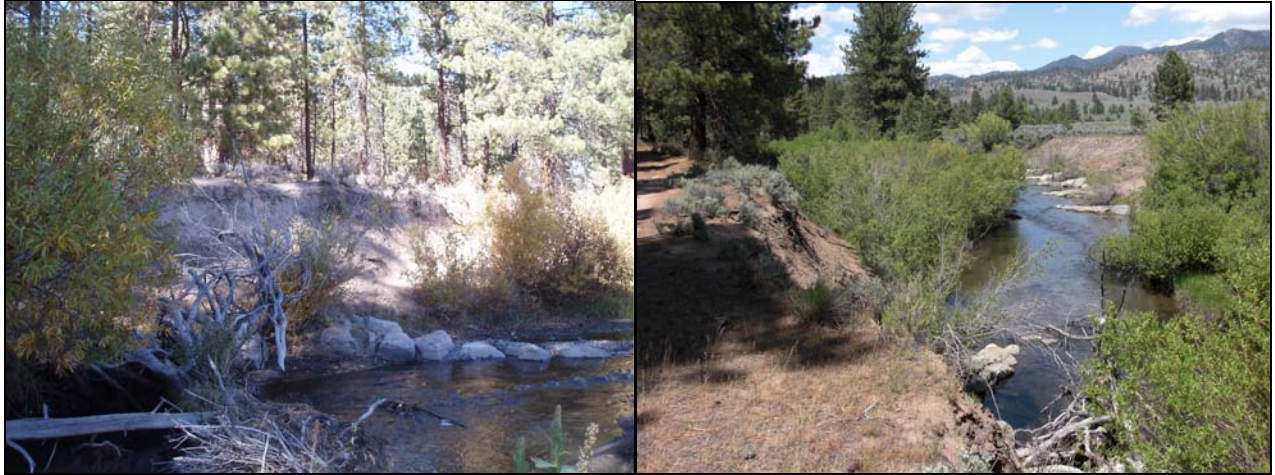
Figures 15 & 16. October 2008 photos. Boulder vane protecting road slope toe.

Improves maintenance of existing infrastructure: One of the treatment areas, using one boulder vane, protected Forest Service road 23N70 from being washed out due to erosion of the road slope toe.

The left photo was taken from the opposite bank. The road is on the terrace at the top of the raw bank. The single boulder vane, which directs flows away from the 23N70 road toe, is in the foreground in the photo on the right. The exaggerated meander on the opposite bank was also treated (five vanes visible in the photo background), which should also help decrease the outcurve migration toward the road.
