WOLF CREEK RESTORATION
PROJECT

Fact Sheet #5

March 1996

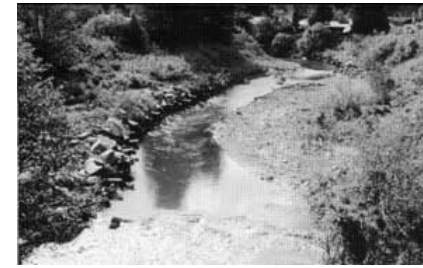
Wolf Creek before the project. this relatively straight section of stream has little flood plain to accommodate flood waters.
