Feather River Coordinated Resource Management Group

BIG FLAT MEADOW RESTORATION PROJECT

Fact Sheet #6

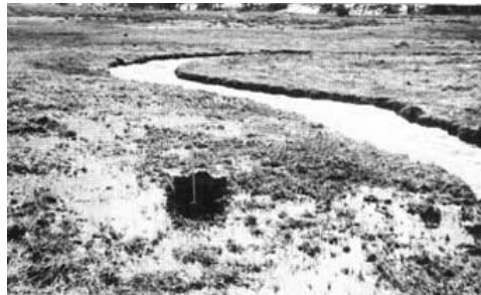
Cottonwood Creek in it's newly constructed channel after the February 1996 flood. The creek has overflowed the smaller channel and is watering the meadow.

The project was tested when a total of six inches of rain fell on the watershed in a sixty hour period during a storm in early February 1996. Water flow in the channel, which was designed to accommodate 40 CFS, was measured at 164 CFS. Water over-flowed the channel and spread out onto the meadow floor as desired. There was no erosion of the project's new channel and the seven ponds filled up with water as expected. Monitoring of the project over the next several years will show whether the project stays in place during bigger storm events.

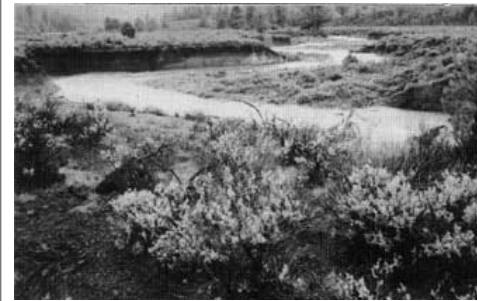
Cottonwood creek as it crossed Big flat Meadow before the project.

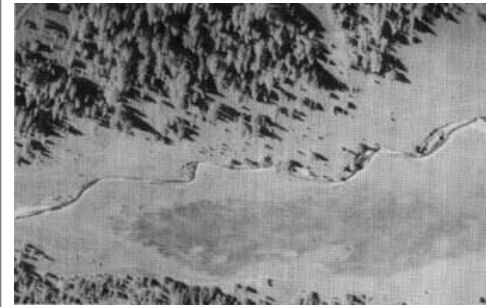
Cottonwood Creek as it crossed Big Flat Meadow before the project

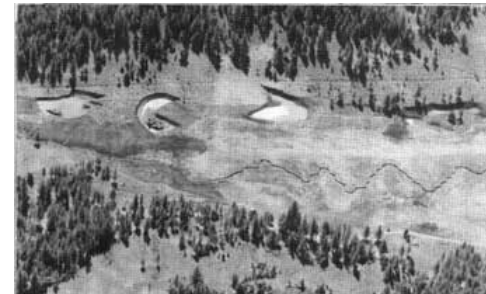
Big Flat meadow after the project. The water has been diverted to the new channel on the other side of the meadow, and the old gully has been converted to ponds

- * Abandonment of the creek's old incised gully. The channel was filled in and sections of it were converted into a series of seven ponds to create wildlife habitat.

- * Diversion of the creek into a new 4,050 foot long section of shallow channel on the meadow floor above. Rock step pools were created in the steepest sections of the new channel to protect against new head cutting in the channel.
