Doyle Crossing – Last Chance Creek

Excerpt from 2021 Sierra Meadows Hydrology Monitoring Annual Report

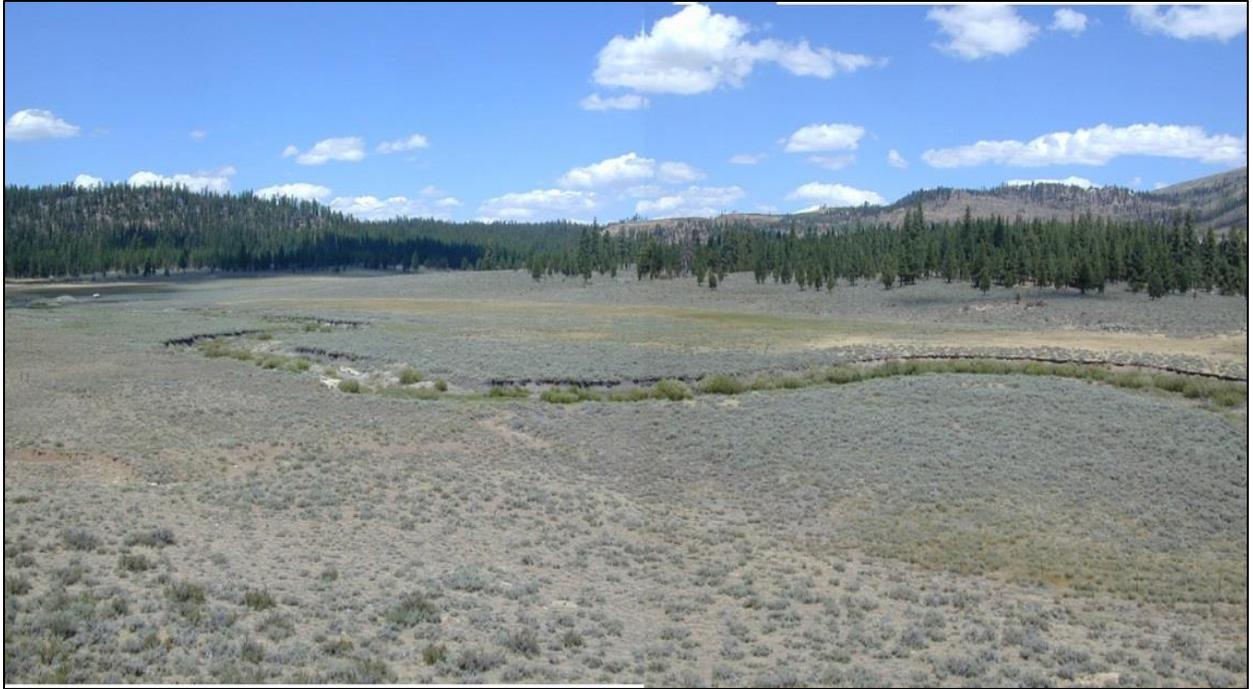
Figure 47. Last Chance Creek- Alkali Flat overview, 2003.

The Last Chance Creek watershed has been the focus of meadow and channel restoration activities since 1995, with the majority of restoration occurring between 2002 and 2007. Figures 47 and 48 illustrate pre- and post- restoration conditions in the Alkali Flat area of Last Chance Creek. In total, approximately 11 miles of channel have been reconnected to the floodplain above the Doyle Crossing station. A continuous recording unit (CRS) unit was installed in Last Chance Creek in 1999. Continuing the long-term data collection at this location is important for evaluating the cumulative impact of multiple meadow restoration projects across a variety of water year types, including severe multi-year droughts. Appendix G provides a map of restoration projects and gage location for the Last Chance Creek monitoring station. Table 11 summarizes the data record for this gage (data gaps exist due to occasional equipment errors). Table 12 provides an overview of field data collected during the 2021 water year.

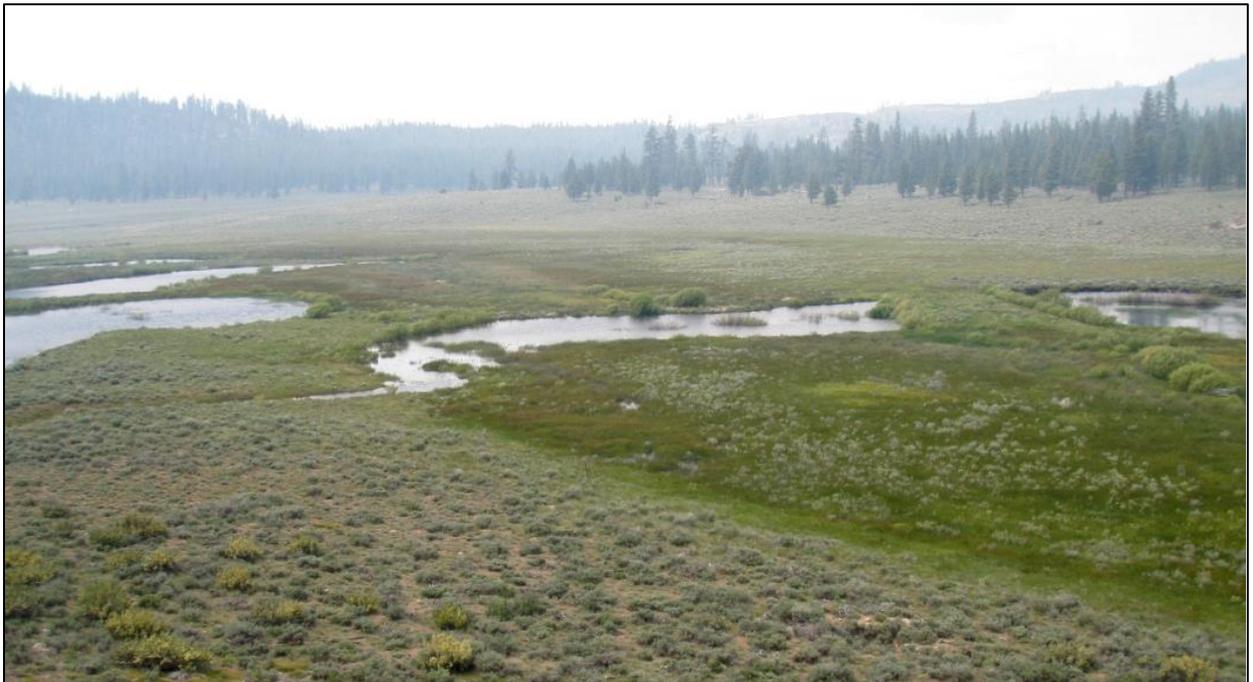
Figure 48. Last Chance Creek- Alkali Flat overview, 2010.
