Doyle Crossing – Last Chance Creek

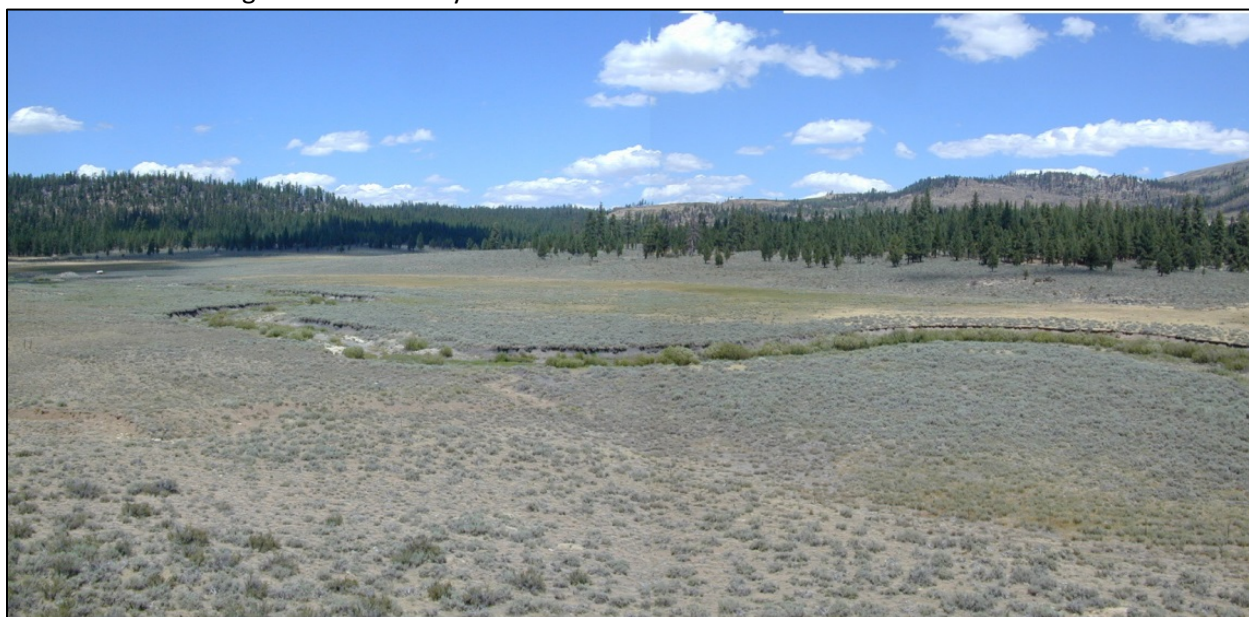
Figure 31. Last Chance Creek- Alkali Flat overview, 2003.

The Last Chance Creek watershed has been the focus of meadow and channel restoration activities since 1996, with the majority of restoration occurring between 2002 and 2007. Figures 31 and 32 illustrate pre- and post- restoration conditions in the Alkali Flat area of Last Chance Creek. In total, approximately 11 miles of channel have been reconnected to the floodplain above the Doyle Crossing station. A CRS unit was installed in 1999. Continuing the long-term data collection at this location is important for evaluating the cumulative impact of multiple meadow restoration projects across a variety of water year types, including severe multi-year droughts. Appendix G provides a map of restoration projects and gage location for the Last Chance Creek monitoring station. Table 15 summarizes the data record for this gage (data gaps exist due to occasional equipment errors). Table 16 provides an overview of field data collected during the 2017 water year.

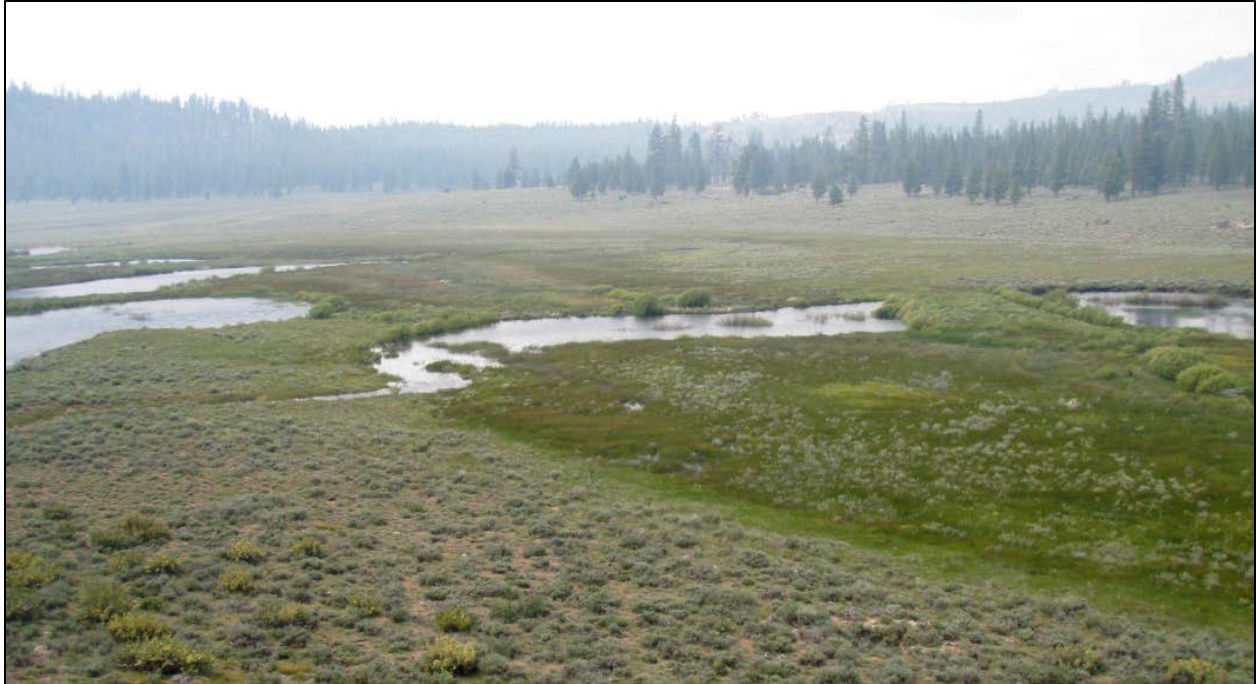
Figure 32. Last Chance Creek- Alkali Flat overview, 2010.

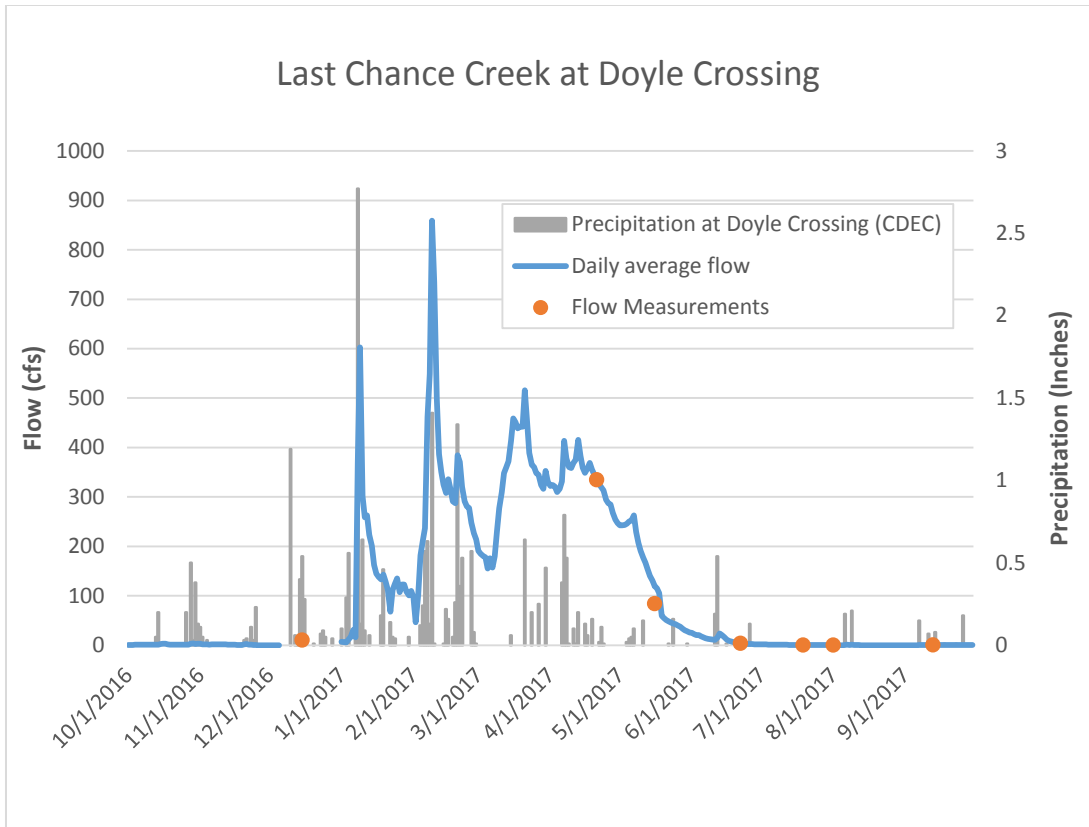
Figure 33. Daily average flow in Last Chance Creek at Doyle Crossing (Source: CRS Keller Model 700 Transducer) and precipitation (Source: Doyle Crossing CDEC), water year 2017.

Stream flow was manually measured in December 2016 and monthly from April through September. The data were used to calibrate the stream stage rating curve and verify the continuously recorded transducer data. Manually-measured stream flows ranged from 335 cfs (April) to 0.59 cfs (August). Daily average flows (Figure 33) from the CRS ranged from 0.02 cfs (8/18/17) to 859 cfs (2/9/17). The large January and February storms drove the high flows achieved during those months. In January, the Doyle Crossing CDEC station recorded 3.92 inches of rain from 1/7/17 through 1/11/17. Average hourly flows in Last Chance Creek reached a peak of 899 cfs on 1/9/17 at 0100 hrs. The February storm event recorded 3.11 inches of precipitation over the seven-day period from 2/4/17 to 2/10/17, with hourly average flows reaching 1090 cfs on 2/9/17 at 2000 hrs. Although peak flows stayed well within the existing rating, they should be considered only as estimates due to the lack of high flow calibration measurements.

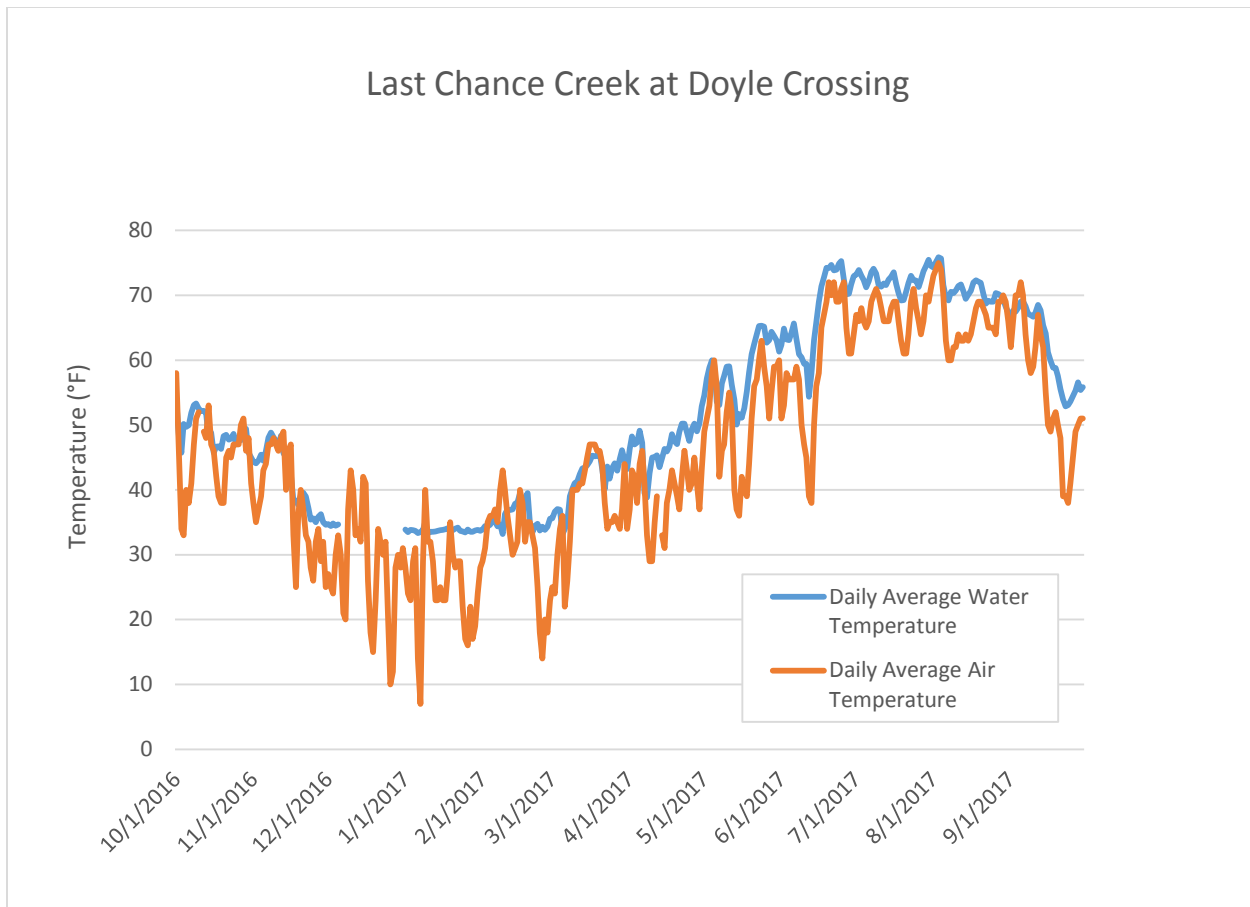
Figure 34. Daily average water temperature in Last Chance Creek (Source: CRS Campbell Scientific Model 107 thermistor) and daily average air temperature (Source: Doyle Crossing CDEC), water year 2017.

Hourly average water temperatures in Last Chance Creek were obtained from the continuous recording station at Doyle Crossing. Daily average water and air temperature data are shown in Figure 34. Future analyses will include an evaluation of diurnal changes in water temperature.
