Final Report
Spanish and Silver Creek Restoration
Projects
Funded by Plumas Watershed Forum

Plumas Corporation
September 2009

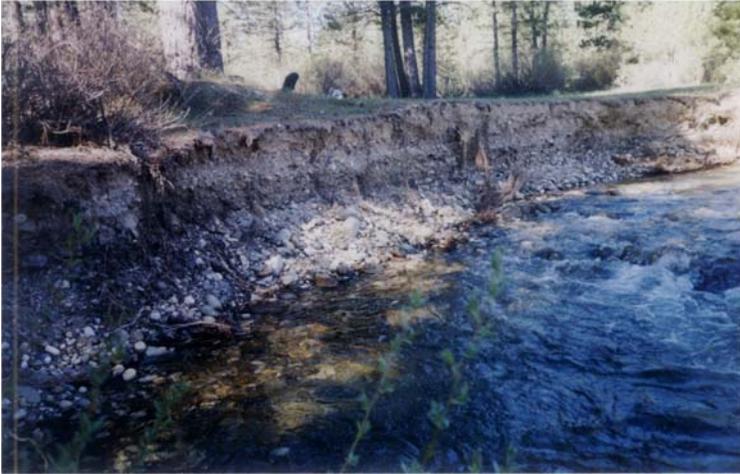
Spanish Creek on Kellett property pre-project eroding bank May 2004.

1. Approximately 200 feet of rapidly eroding stream bank was reconstructed to a configuration that evenly distributed the stress of turning water flows.
2. Four large boulder vanes were built at floodplain elevation along the reconstructed bank to keep the center of highest flow (thalweg) away from the bank. The upper bank was vegetated with transplanted material from on-site and seedlings from the community greenhouse at Feather River College.
3. Four large gravel berms, each approximately 1200 cubic yards, were removed from the active floodplain.

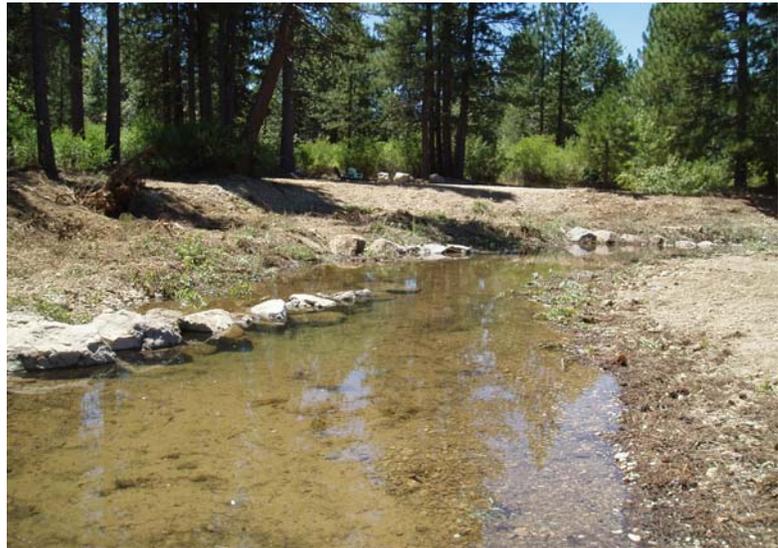
Spanish Creek, post- construction August 1, 2008, showing reconstructed bank with boulder vanes and transplanted vegetation.

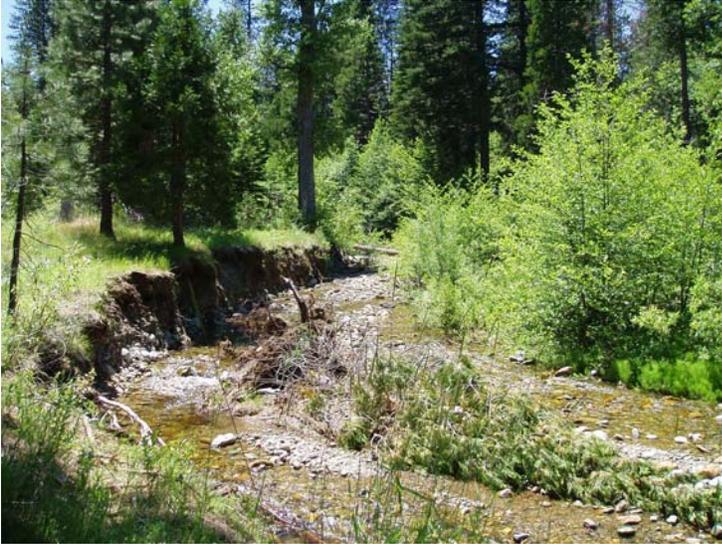
Silver Creek pre-project June 2, 2005 showing vertical eroding bank.

5. The 90° bend near the downstream end of the project reach was stabilized with boulder vanes and vegetation transplants.
6. All vertical banks were laid back and vegetated with on-site transplants and native grass seed to provide a measure of protection during periods of high flow overbank and reentry into the channelway, especially along the downstream project reach.

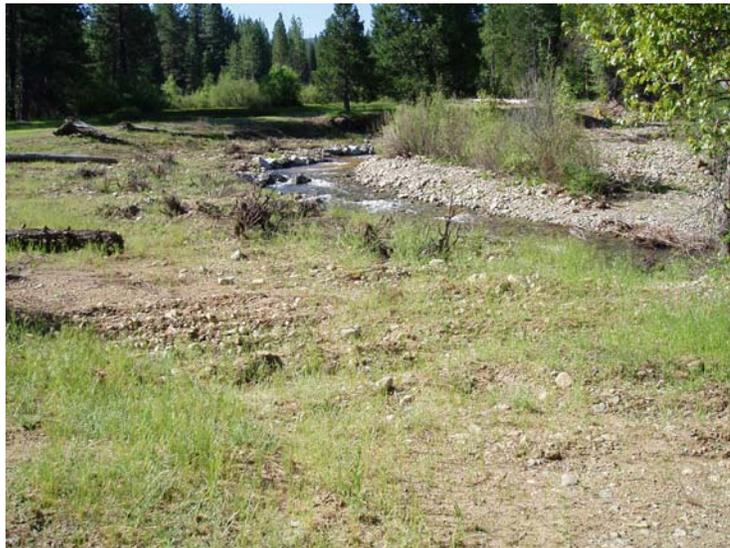
Silver Creek post-project May 23, 2009. Bank is laid back and terraced, with boulder vanes in channel directing flows away from the outcurve bank. Vegetation was planted/seeded on the terraced floodplain.

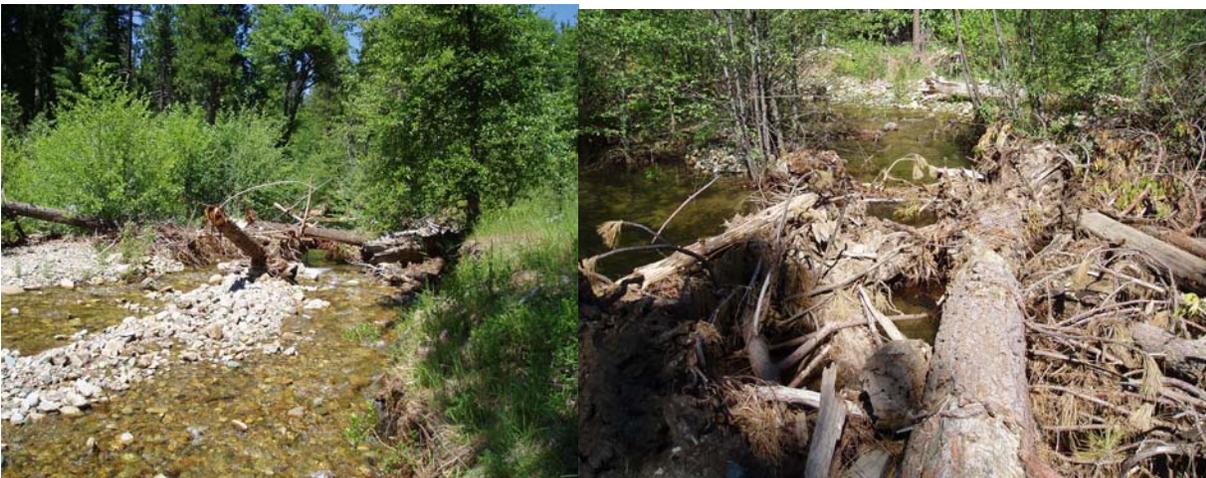
Pre- (6/2/05) project woody debris jam on Silver Creek; enhanced debris jam post- (5/23/09) project.

Note: Whole trees are used and restricted from floating by crossing over the mass with the largest trees held in place by placing their ends on the upper banks and counter-weighting with large boulders. Each jam was also filled with sand, gravel, and cobble material from adjacent bars.

3. The whole tree jam located 250 feet downstream from the bridge was improved.
4. The property is being managed into perpetuity to allow large trees to grow, die and eventually fall into the channel, providing a source of large wood recruitment.

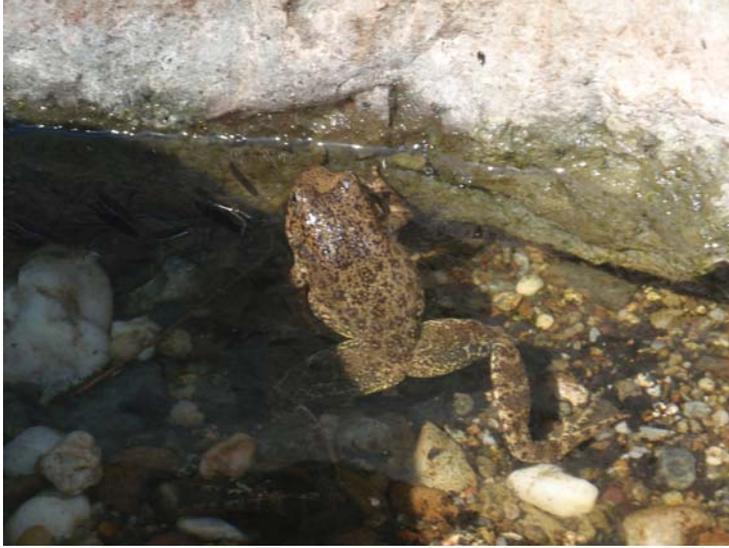
Yellow-legged frog found under boulder vane on Spanish Creek, August 20, 2009.

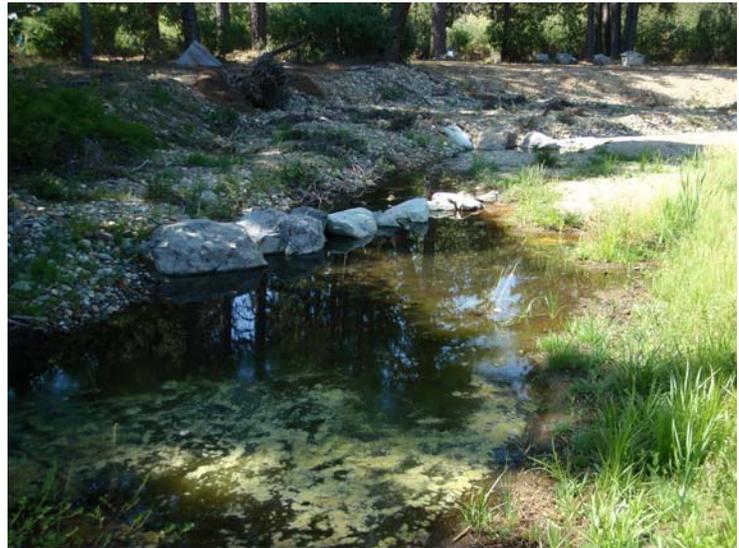
Habitat along boulder vanes where yellow-legged frog was detected on August 20, 2009.
