# **Joint Final Report**

## **Little Last Chance Creek at Guidici Ranch Restoration Project**

**Prepared by  
Plumas Corporation  
January 2009**

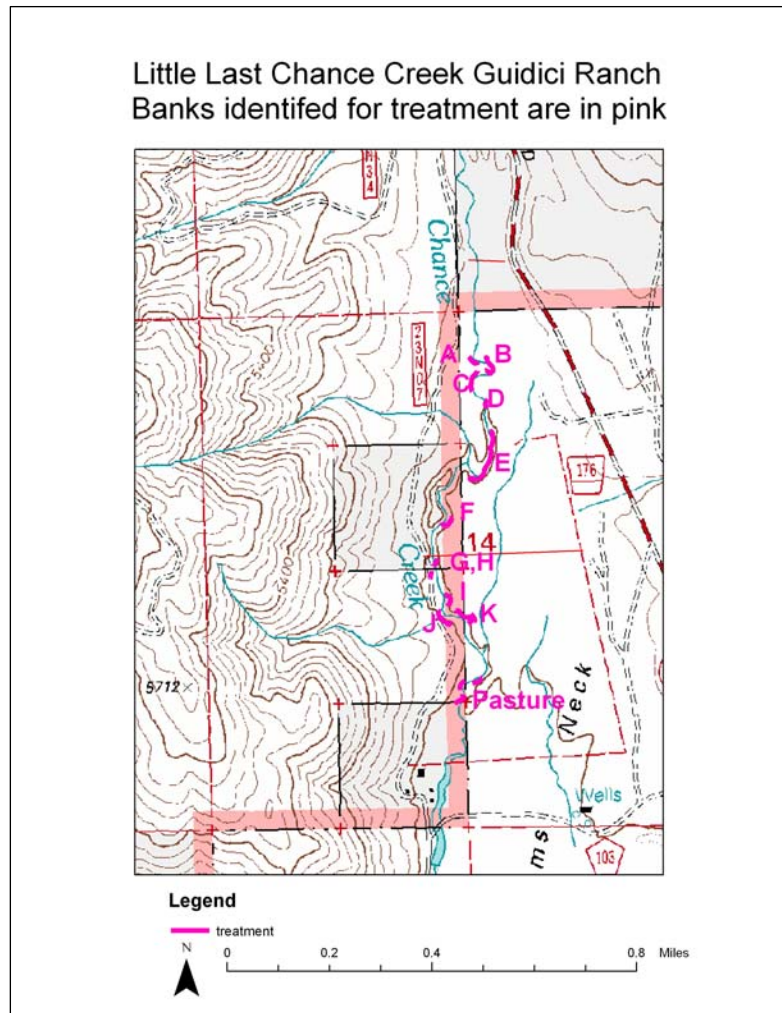
Figure 2 shows the locations of bank treatment areas:

Approximately 1,135 cubic yards of 3-foot minus boulders from the Bar One Ranch pit in Sierra Valley were used to construct 71 boulder vanes in 12 treatment areas. Areas B & C were not treated because of a natural trend toward stability. Re-vegetation work consisted of:

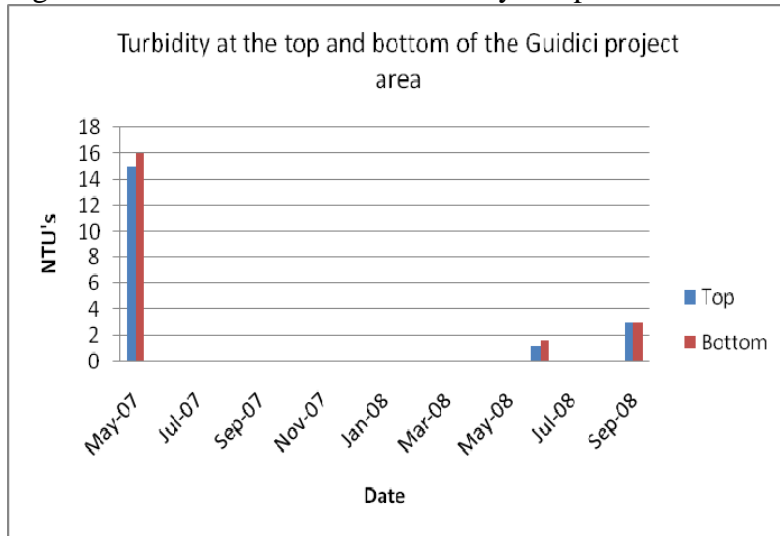
Figure 12. Results from a few turbidity samples.

One turbidity sample was collected before the project in May 2007. Two samples were collected post-project in 2008. It appears that there is not a clear difference in turbidity between pre- and post-project conditions on the sample dates. Samples collected at the top of the project area were collected just above Guidici's upper diversion dam. Samples collected at the bottom were collected just above the diversion dam at the bridge by the Guidici Ranch house.

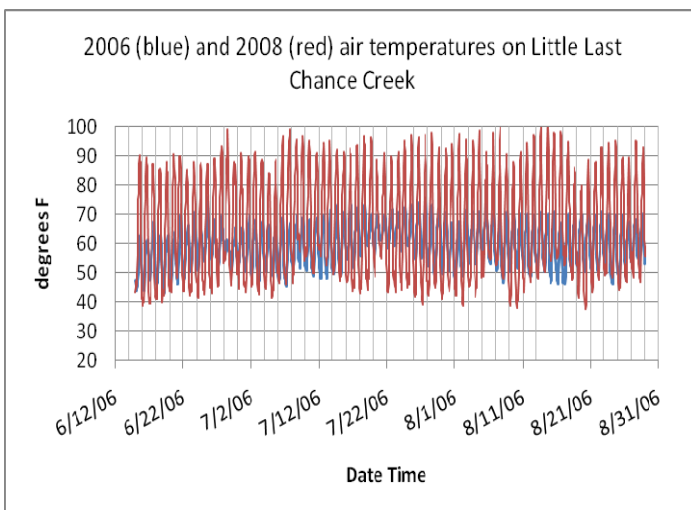
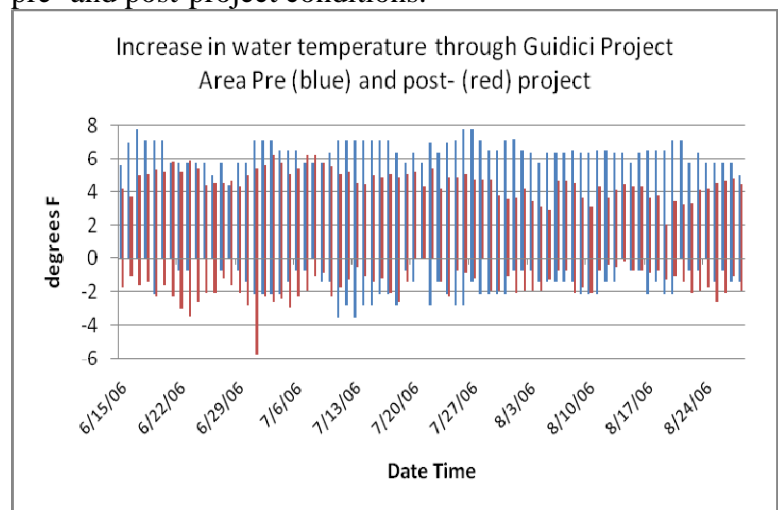
Figures 13 & 14. Comparison of hourly air and water temperatures through the project area in pre- and post-project conditions.

Water temperature was measured both above and below the project area, before the project in 2006, and the first year after the project in 2008. One would expect that cold water from Frenchman Dam would warm as it moves through the project area in the summer months. This was the case in both 2006 and 2008. Although, the smaller increase in 2008, is most likely due to the location of the hobotemp, which was in the dam pool in 2008, but just above the dam pool in 2006. In both

years, the data also show an interesting periodic decrease in water temperatures through the project area in both years, indicated by negative numbers in Figure 14. This decrease tended to occur in the late afternoon, and is likely due to cooler subsurface irrigation return flows from the terraced meadow entering the channel through the gully walls.
