# **Appendix A**

## **Flood Frequency Analysis**

### **Upper Spanish Creek Watershed**

## **Spanish Creek Rehabilitation Project Concept Description**

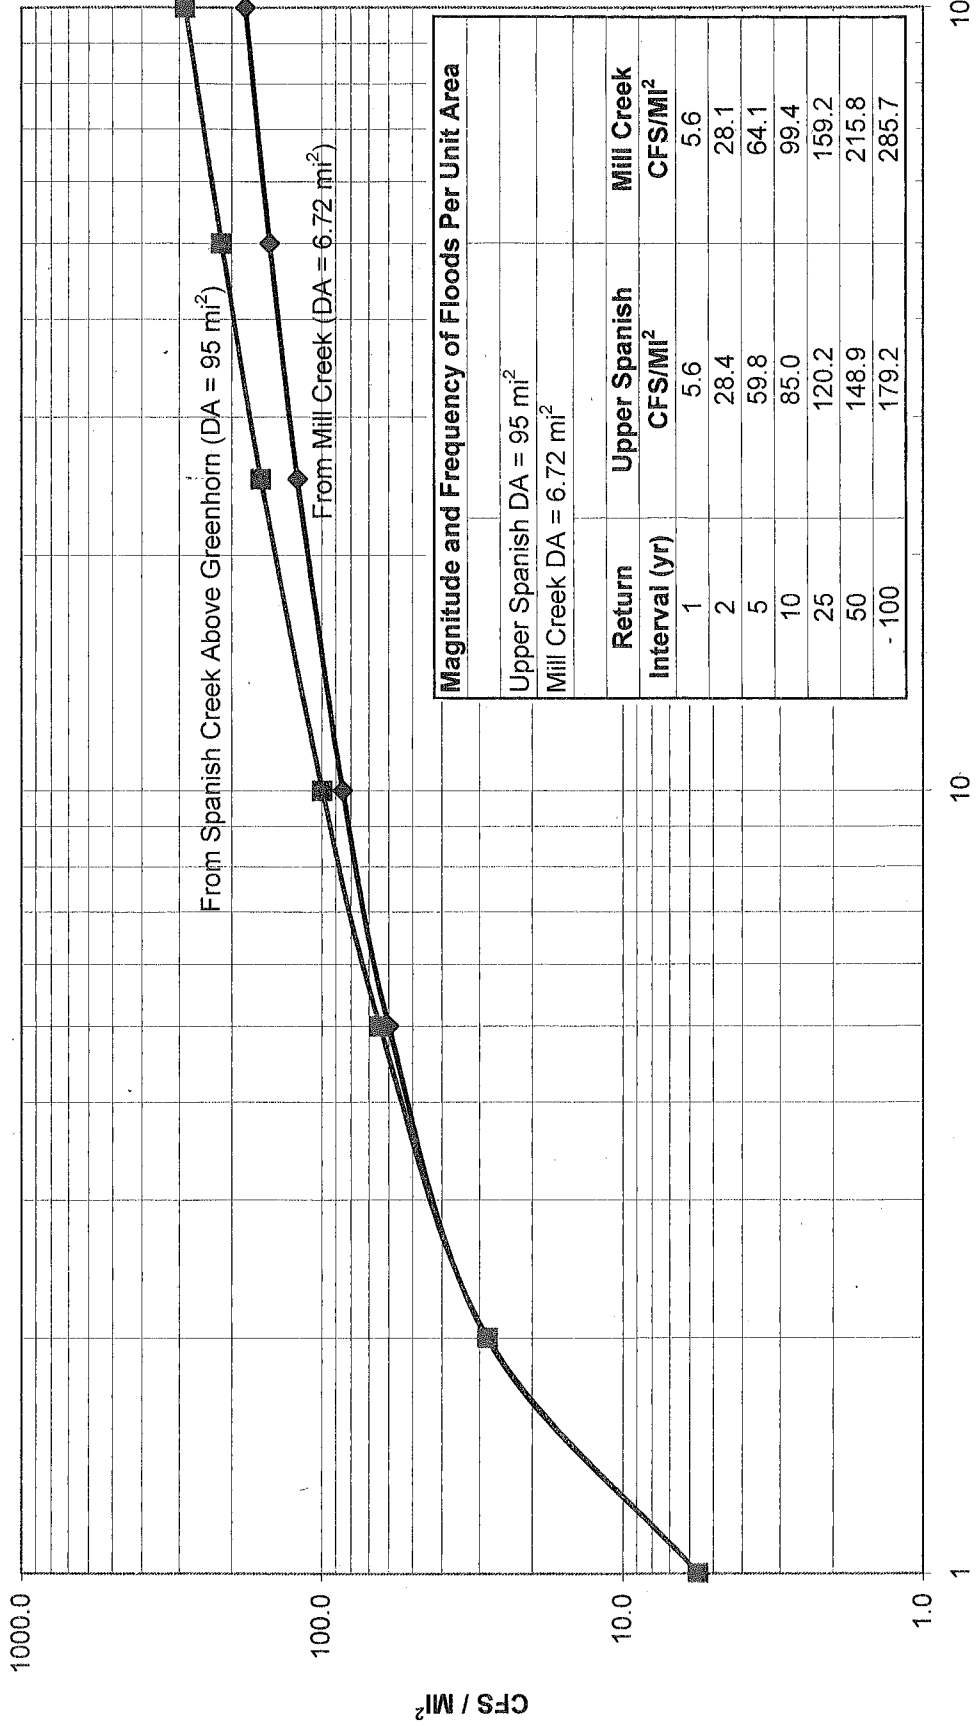
# Magnitude and Frequency of Floods Per Unit Area Upper Spanish Creek

**Magnitude and Frequency of Floods Per Unit Area**

Upper Spanish DA = 95 mi<sup>2</sup>  
 Mill Creek DA = 6.72 mi<sup>2</sup>

Return Interval (yr)	Upper Spanish CFS/MI <sup>2</sup>	Mill Creek CFS/MI <sup>2</sup>
1	5.6	5.6
2	28.4	28.1
5	59.8	64.1
10	85.0	99.4
25	120.2	159.2
50	148.9	215.8
- 100	179.2	285.7

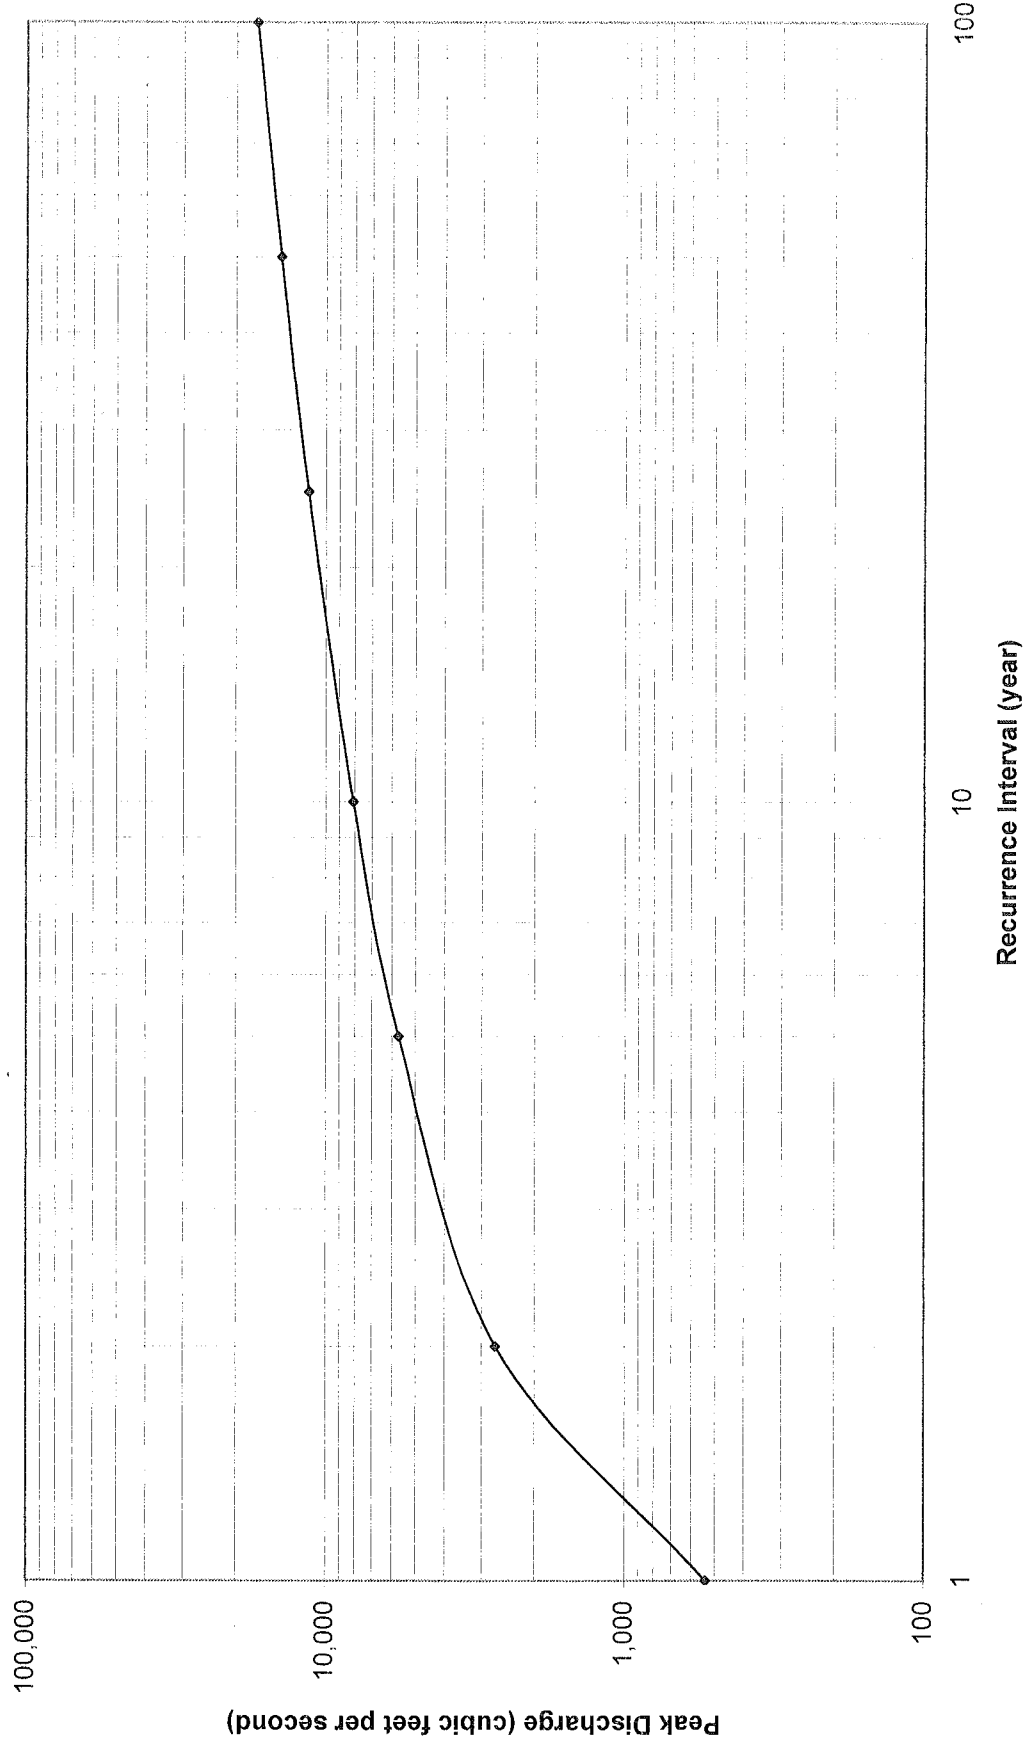
**Magnitude and Frequency of Floods  
Upper Spanish Creek (DA = 95 mi<sup>2</sup>)**

Location	Peak Discharge (cubic feet per second) at Indicated Recurrence Intervals									
	Area (mi <sup>2</sup> )	1-yr (0.990)	2-yr (0.500)	5-yr (0.200)	10-yr (0.100)	25-yr (0.400)	50-yr (0.020)	100-yr (0.010)	200-yr (0.005)	420-yr (0.001)
Spanish Gage @ Keddle	184	958	4,790	9,706	13,625	19,135	23,551	28,169	32,975	42,015
Spanish abv Greenhorn @ 60% of Gage	95	575	2,874	5,824	8,175	11,481	14,131	16,901	20,174	25,569
Spanish abv Greenhorn by $Q_{10} = Q_g(A_u/A_g)^b$	95	535	2,694	5,678	8,075	11,415	14,141	17,025	20,174	25,569
		0.89	0.88	0.82	0.80	0.79	0.78	0.78	0.78	0.77

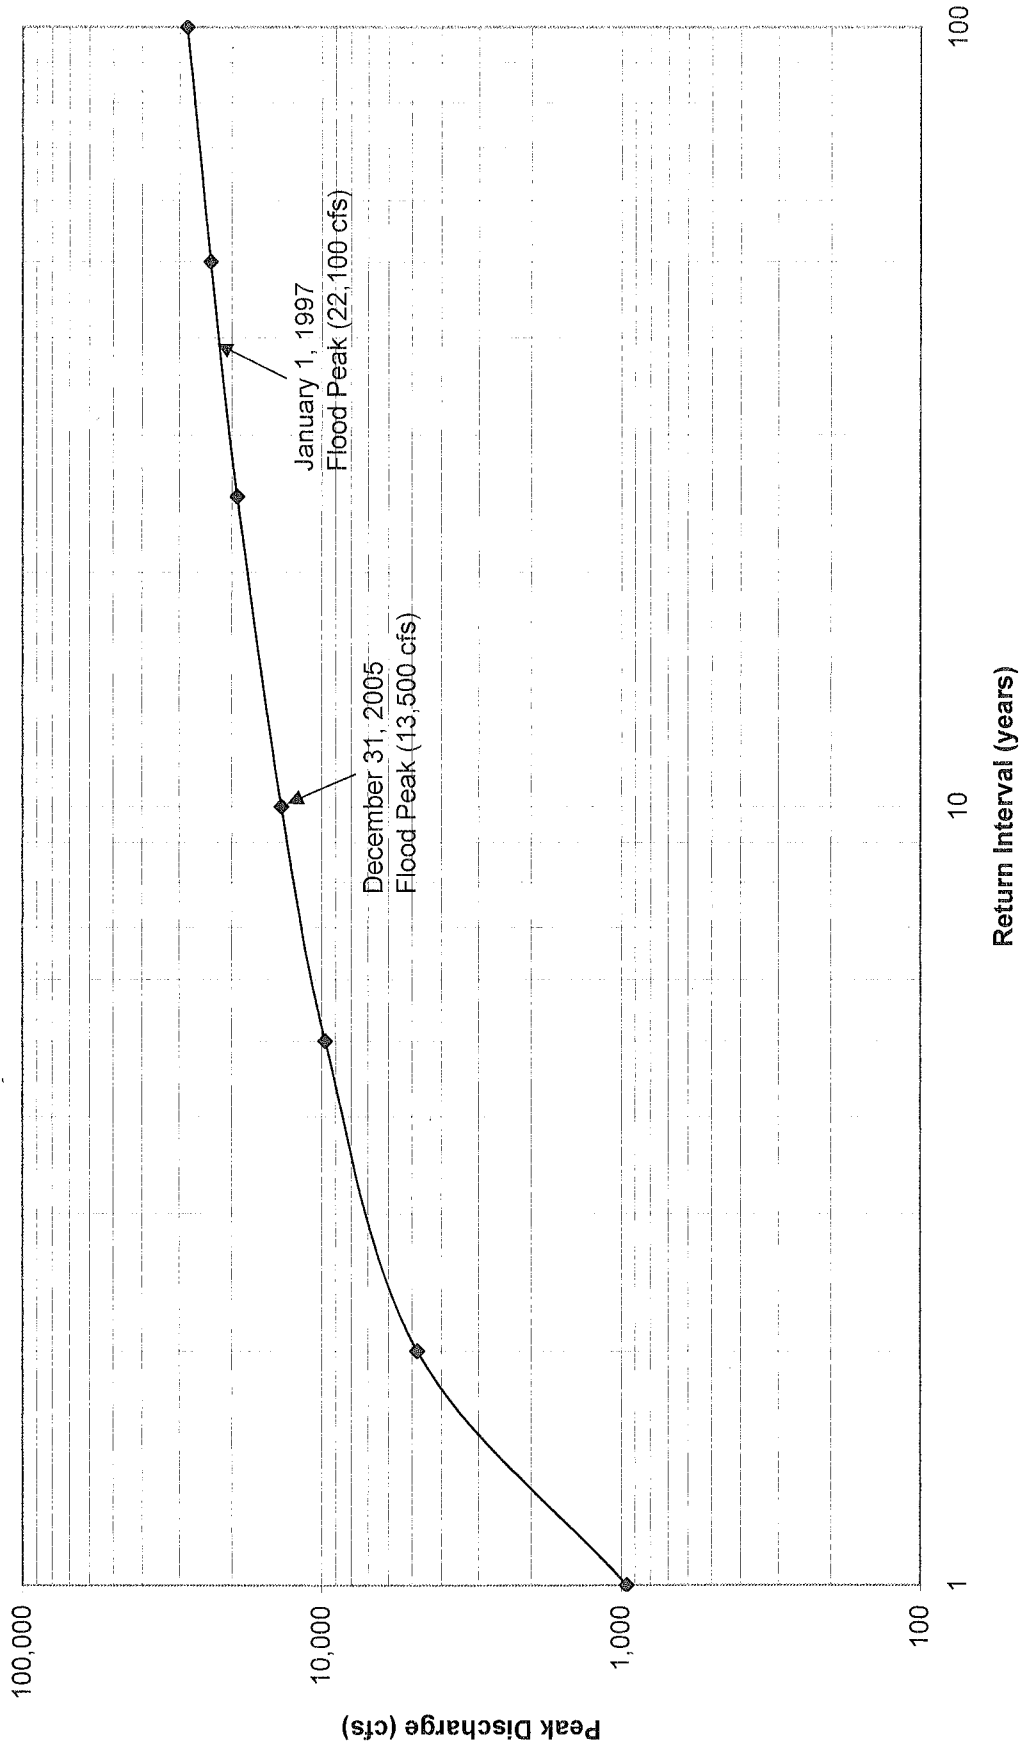
**Magnitude and Frequency of Floods  
Spanish Creek at Keddie (DA = 184 mi<sup>2</sup>)**

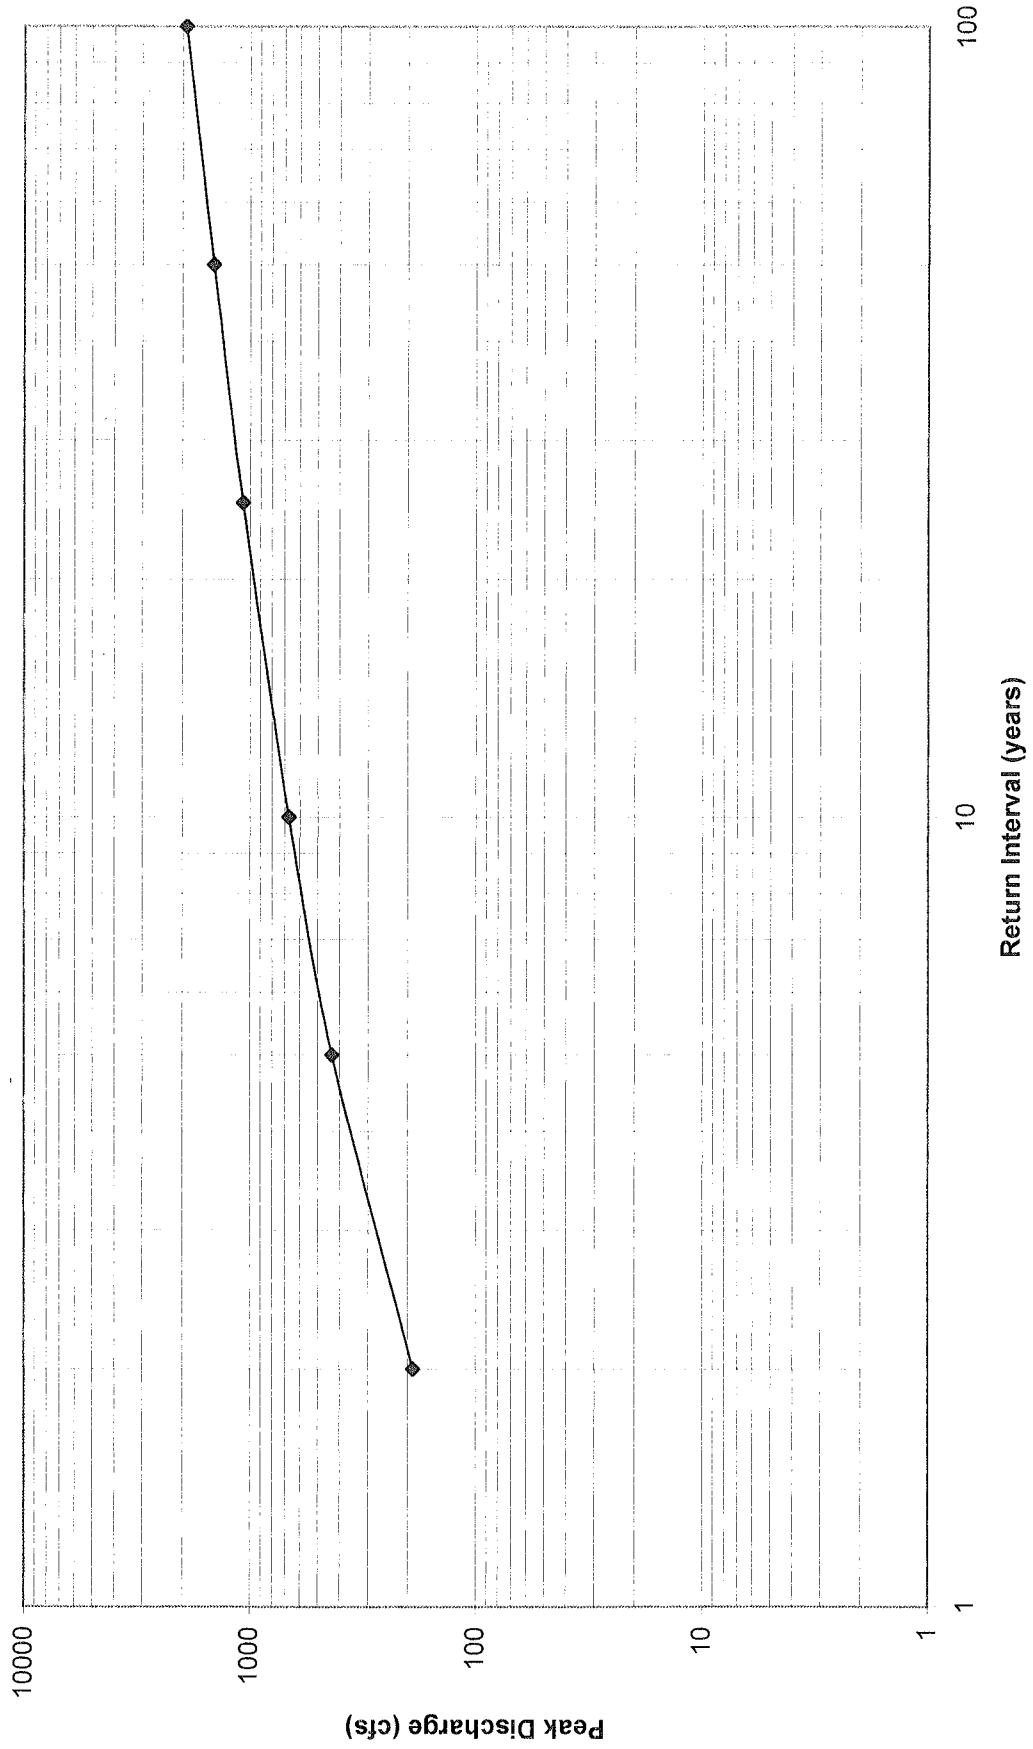
Magnitude and Frequency of Floods  
Mill Creek (DA = 6.72 mi<sup>2</sup>)
